ISCO CASE STUDY: ACTIVATED SODIUM PERSULFATE TREATMENT OF MTBE IN GROUNDWATER, CAMP PENDLETON MARINE CORPS BASE, CA

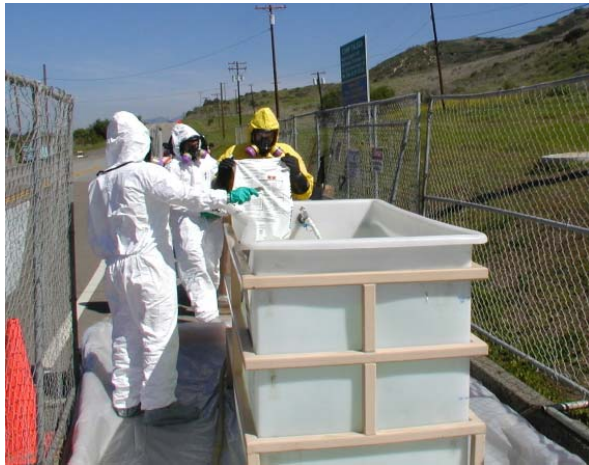
completed over two injection events approximately 4 months apart.

Over the course of this project, a total of 14,000 gallons (16,000 pounds of sodium persulfate and 4,000 pounds of iron EDTA) were mixed into solution and injected into the groundwater. The injections were

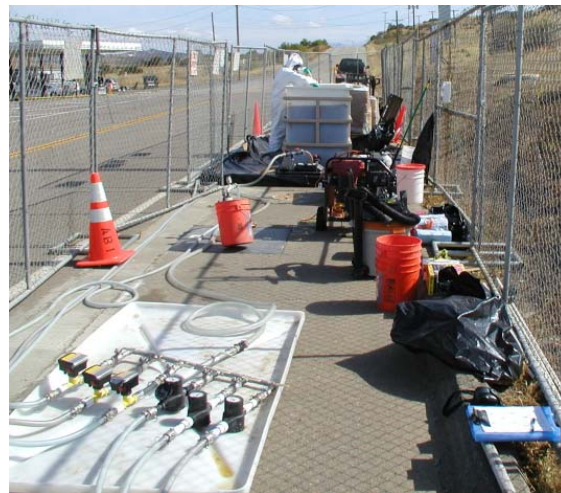
During the injections, JAG Consulting also provided water quality measurements of pH, dissolved oxygen, ORP, conductivity, and temperature in nearby monitoring wells, which helped to determine whether oxidizing conditions were being achieved throughout the treatment zone.

Water quality measurements taken during the injections indicated that the injection well spacing was slightly too far apart for the radius of influence and that additional injection wells would be required.
